**Flood Control Project Maintenance  
Levee Inspections**  
**LMA District Cover Sheet**  
**Spring 2019 Levee Inspection Results**

**Knights Landing Ridge Drainage District**

**Spring 2019 Levee Inspection Results**

Waterway			Bank	Unit Miles
Unit No. 01 Knights Landing Ridge Cut			Right	6.36
	Spring (March - May)	Summer (June - August)	(September - November) Fall	Winter (December - February)
Unit Maintenance Rating (Fall Only)				
Date of Inspection	4/4/2019 - 4/4/2019			
DWR Inspector	Zach Jojola			
Accompanied By	Gary Marler RD0108

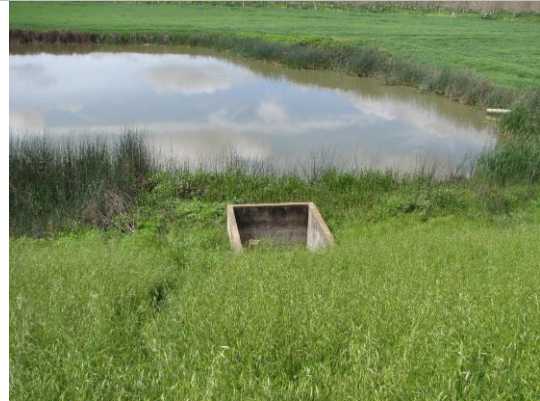
Photo 1 of 3 : UCIP\_SP\_2019\_53529\_21582.jpg

Comment Code						
Inspector Comment						
FS_ID:53529 DS_ID:19360 EP_NO: 9302 Repair Type: No Action Needed Crossing Status: Found UCIP Comments: 12/07/2018 Need updated photos to show proper pipe abandonment. Update Part VI, 1. Pipe Section to remove part c and e. If crossing was abandoned properly crossing will need to be removed from the LMA responsibility list. (O. Magana - DWR UCIP)05/16/2016 Pipe has been grouted in place under permit 18987, 2015. (T. Hatch - DWR UCIP)04/05/2013 Pipe completely rusted through on LS slope of levee at toe/headwall of concrete distribution box. Pipe needs replacement or proper abandonment. Pipe not visible at outlet. (W. Wylie - DWR UCIP) FIELD_STRUCT_DESC: *ABANDONED* 36-inch corrugated metal drainage pipe through the levee, 27 feet below the crown. Slide gate on the waterside (WS) end. 12-foot by 6-foot concrete box on the landside (LS) end. (36-inch pipe [HLM 1.62] authorized under Automatic Board Order (ABO) issued as Permit No. 9302, 1974 - Barbara Lowe Elliott; 36-inch pipe abandoned by removing ends and pumping pipe full of concrete under Permit No. 18987, 2016 - Knaggs Ranch, LLC, care of John Brennan). [Additional Reference(s): DWR Levee Log, 1990. USACE Sacramento O&M Manual 127, June 1953, (Station 0+30)]. FS Date: 5/16/2016 3:59:00 PM

Concrete distribution box on LS toe.

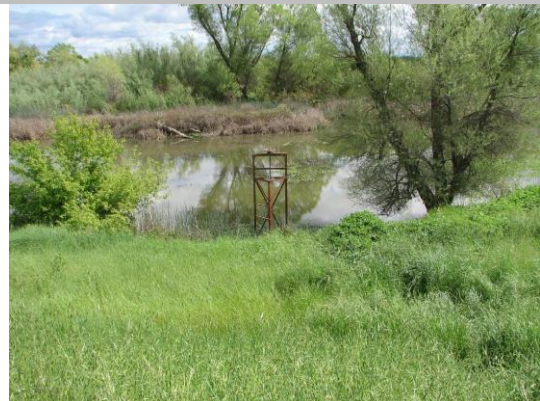
Photo 2 of 3 : UCIP\_SP\_2019\_53529\_21581.jpg

Slide gate on metal stand on WS toe. Pipe opening not visible.

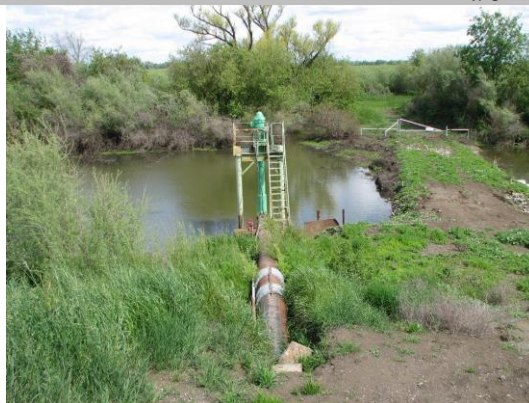
Photo 1 of 3 : UCIP\_SP\_2019\_11064\_18426.jpg

Comment Code						
Inspector Comment						
FS_ID:11064						
DS_ID:19361						
EP_NO: 9302						
Repair Type: Non-Urgent						
Crossing Status: Found						
UCIP Comments: Pipe exposed on WS slope in trench may need to be backfilled to prevent erosion under pipe.						
FIELD_STRUCT_DESC: 20-inch steel irrigation pipe through the levee, 8.8 feet below the crown. Pump on a steel pile structure at the waterside (WS) toe. Siphon breaker in a 12-inch steel riser on the landside (LS) slope. Possible butterfly valve at the LS toe. (Permit No. 9302, 1974 - Barbara Lowe Elliott). [Additional Reference(s): DWR Levee Log, 1990. USACE Sacramento O&M Manual 127, June 1953, (Station 32+94)].						
FS Date: 4/5/2013

Pump on pile at WS toe with pipe in open trench on LS slope.

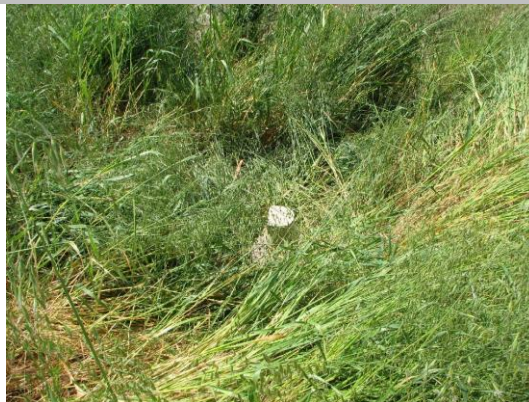
Photo 2 of 3 : UCIP\_SP\_2019\_11064\_18425.jpg

Siphon breaker in 12-inch steel riser on LS slope.

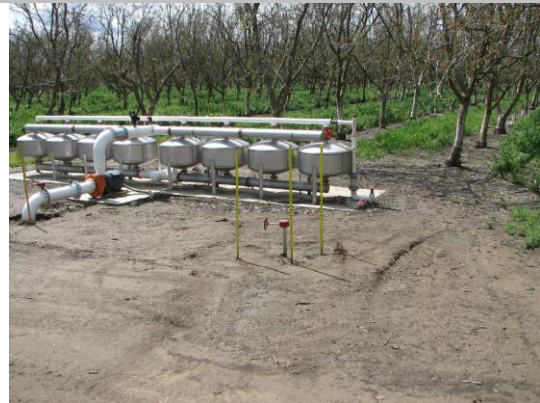
Photo 3 of 3 : UCIP\_SP\_2019\_11064\_18424.jpg

Possible butterfly valve off LS toe.

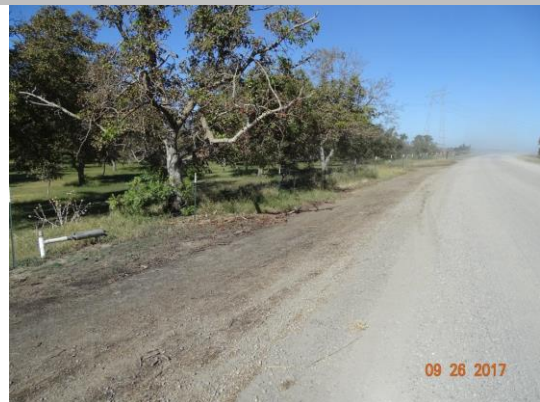
Photo 1 of 1 : SP\_2019\_NA0008\_256\_26\_20190304\_00009.jpg

LM Start	1.13	Rating **	M	Issue No.	26
LM End	1.29	Issue Type +	En	Location *	LS
Category	Earthen Levee			GPS Latitude/Longitude	
				Start	End
Item	Encroachments			38.730134 °	38.731873 °
				-121.678820 °	-121.680739 °
DWR ID	DWR_NA0008_01_f_2017_26				
Comment Code					
FE : Fence					
Inspector Comment					
A barbed wire fence is located on the landside slope.

View of fence on the landside slope. Fall 2017.

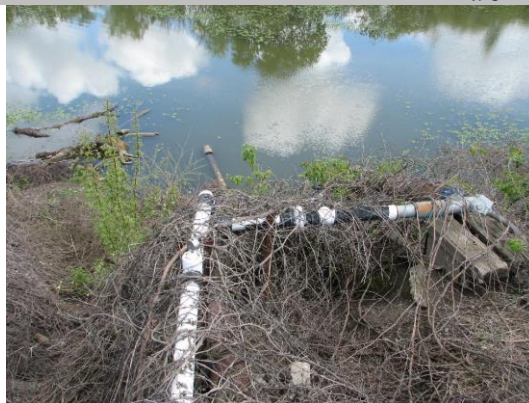
Photo 1 of 3 : UCIP\_SP\_2019\_11065\_18429.jpg

Comment Code					
Inspector Comment					
FS_ID:11065 DS_ID:19362 EP_NO: 9305 Repair Type: Non-Urgent Crossing Status: Found UCIP Comments: Slope on WS shoulder appears to be eroding at pipes exit from levee. 36-inch conc riser on LS is filled with mud. FIELD_STRUCT_DESC: 10-inch steel irrigation pipe through the levee, 5.8 feet below the crown. Pump at the waterside (WS) toe. 36-inch concrete standpipe at the landside (LS) toe. (Permit No. 9305, 1974 - Albert L. Bacchini). 5-inch steel pipe sleeved through the 10-inch pipe. Annular space grouted. (Permit No. 6076, 1968 - Albert L. Bacchini). [Additional Reference(s): DWR Levee Log, 1990. USACE Sacramento O&M Manual 127, June 1953, (Station 47+00) (11-inch pipe listed)]. FS Date: 4/5/2013

Pump on WS shoulder overgrown and may be abandoned.

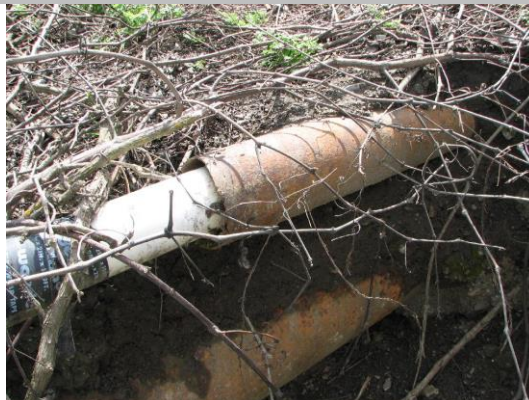
Photo 2 of 3 : UCIP\_SP\_2019\_11065\_18428.jpg

Erosion at pipes exit from levee on WS shoulder.

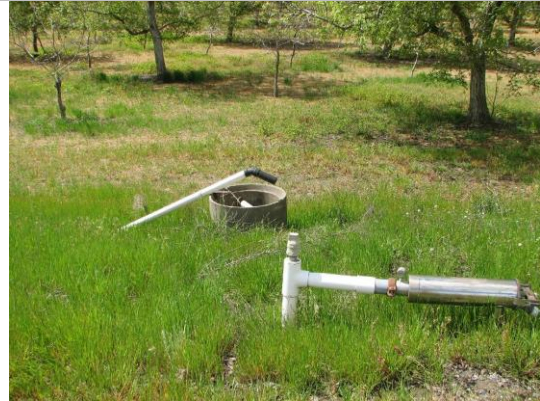
Photo 3 of 3 : UCIP\_SP\_2019\_11065\_18427.jpg

36-inch Concrete standpipe at LS toe

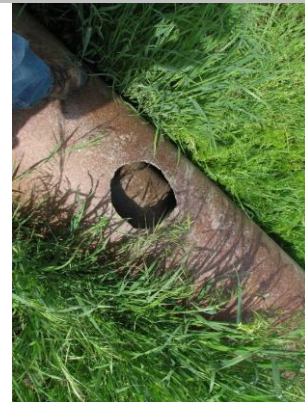
Photo 1 of 3 : UCIP\_SP\_2019\_13204\_21588.jpg

Comment Code						
Inspector Comment						
FS_ID:13204						
DS_ID:19363						
EP_NO: 9302						
Repair Type: Non-Urgent						
Crossing Status: Found						
UCIP Comments: Space between 16-inch and 24-inch pipe should be grouted. There is no pump on stand at WS toe.						
FIELD_STRUCT_DESC: 24-inch steel irrigation pipe through the levee, 5.9 feet below the crown. 16-inch steel pipe sleeved through this pipe. No visible control valves. Pump on a pile structure in the stream.						
Siphon breaker on the landside (LS) slope. Pipe discharges into a concrete irrigation ditch off the LS toe. (Permit No. 939, 1943 - W. K. Lowe). [Additional Reference(s): DWR Levee Log, 1990. USACE Sacramento O&M Manual 127, June 1953, (Station 71+25)].						
FS Date: 4/5/2013

16-inch pipe sleeved through 24-inch pipe on WS slope.

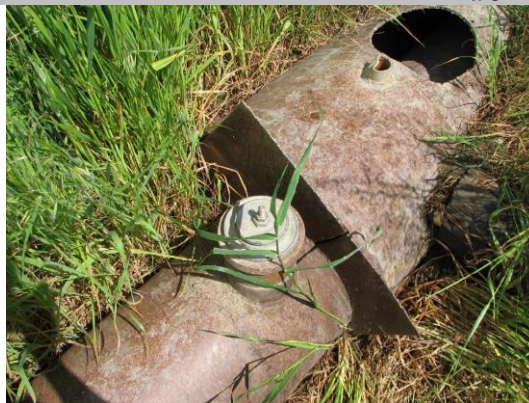
Photo 2 of 3 : UCIP\_SP\_2019\_13204\_21590.jpg

Siphon breaker on LS slope.

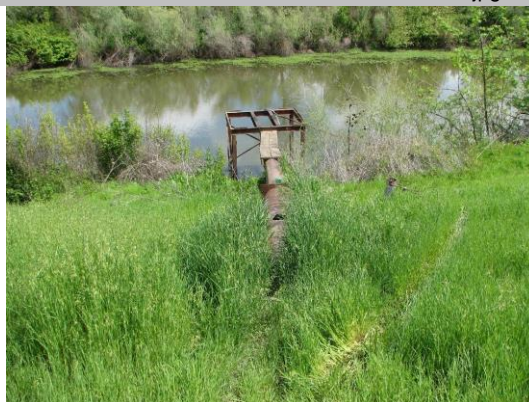
Photo 3 of 3 : UCIP\_SP\_2019\_13204\_21589.jpg

Pipe and pier on WS toe.

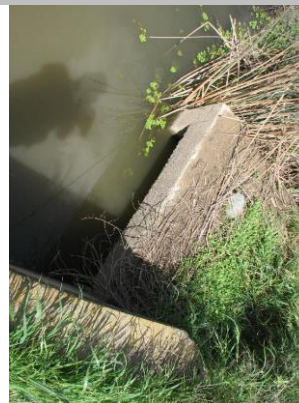
Photo 2 of 3 : UCIP\_SP\_2019\_13205\_21601.jpg

Concrete inlet on LS toe.

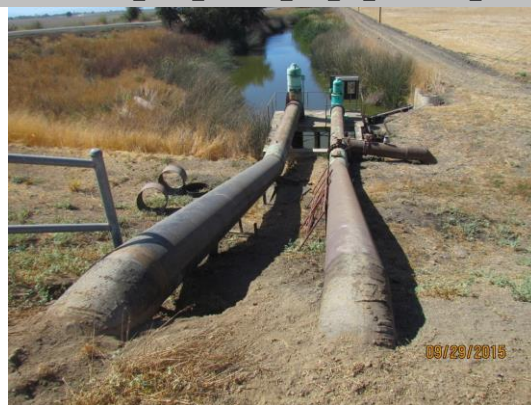
Photo 1 of 2 : SP\_2019\_NA0008\_256\_18\_20190304\_00003.jpg

LM Start	2.70	Rating **	M	Issue No.	18
LM End	2.70	Issue Type +	En	Location *	LS
Category	Earthen Levee			GPS Latitude/Longitude	
				Start	End
Item	Encroachments			38.748837 °	38.748837 °
				-121.694823 °	-121.694823 °
DWR ID	DWR_NA0008_01_f_ 2015_18				
Comment Code					
DE : Debris					
Inspector Comment					
A portion of the pipe seems to have been replaced and the abandoned pipe is left at the toe of the landward side of the levee.

The dark portion on the left pipe seems to have been replaced with a new pipe. Fall 2015.

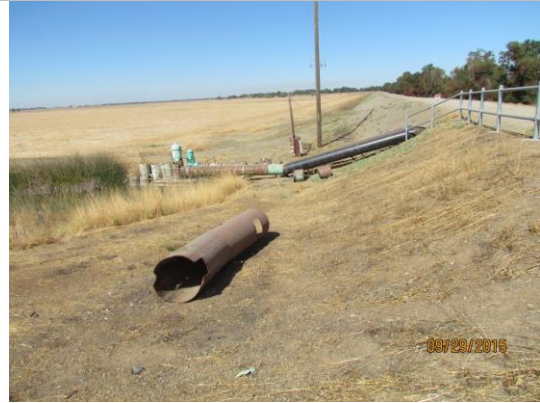
Photo 2 of 2 : SP\_2019\_NA0008\_256\_18\_20190304\_00004.jpg

View of the abandoned pipe at the toe of levee on the landward side.  
Fall 2015.

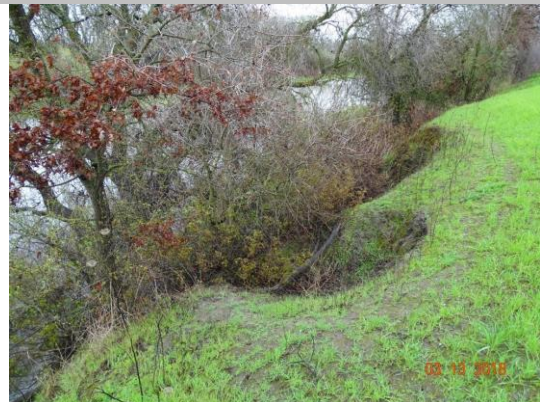
Photo 1 of 2 : SP\_2019\_NA0008\_256\_20\_20190304\_00005.jpg

LM Start	3.50	Rating **	M	Issue No.	20
LM End	3.50	Issue Type +	Ma	Location *	WS
Category	Earthen Levee			GPS Latitude/Longitude	
				Start	End
Item	Erosion / Bank Caving			38.759910 °	38.759910 °
				-121.696920 °	-121.696920 °
DWR ID	DWR_NA0008_01_f_2015_20				
Comment Code					
E2 : Schedule repair of erosion site prior to the next inspection.					
Inspector Comment

View of erosion on the waterside slope. Spring 2018.

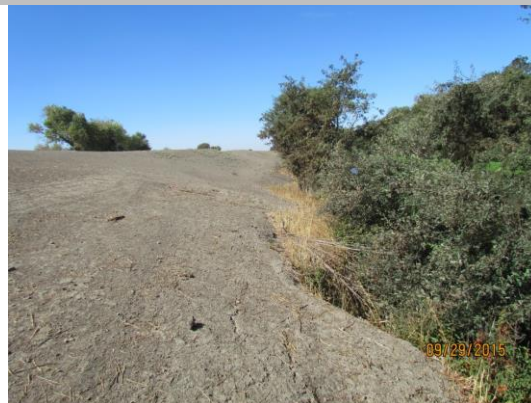
Photo 2 of 2 : SP\_2019\_NA0008\_256\_20\_20190304\_00006.jpg

View of the erosion on the waterward side of the levee looking upstream. Fall 2015.

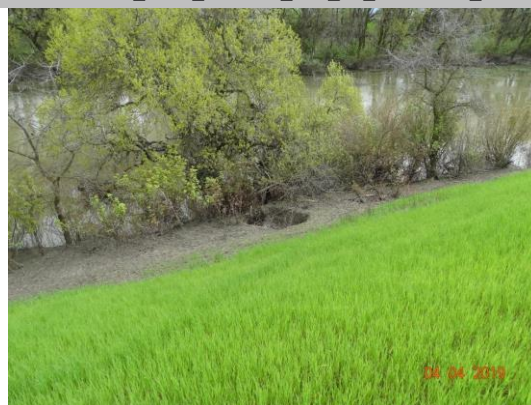
Photo 1 of 1 : SP\_2019\_NA0008\_256\_30\_20190404\_00040.jpg

LM Start	3.78	Rating **	M	Issue No.	30
LM End	3.78	Issue Type +	Ma	Location *	WS
Category	Earthen Levee			GPS Latitude/Longitude	
				Start	End
Item	Erosion / Bank Caving			38.762886 °	38.762886 °
				-121.700406 °	-121.700406 °
DWR ID	DWR_NA0008_01_s_2017_30				
Comment Code					
E2 : Schedule repair of erosion site prior to the next inspection.					
Inspector Comment					
There is a hole from a fallen tree at the waterside toe.

View of hole at the waterside toe. Spring 2019.

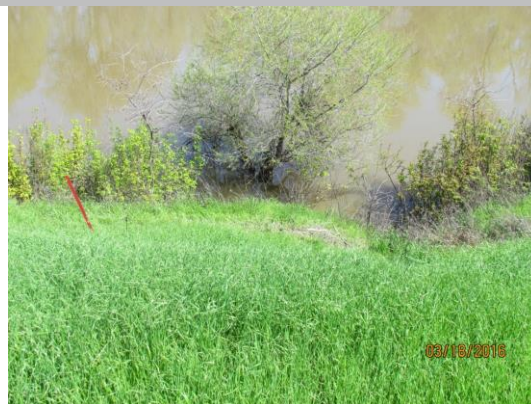
Photo 1 of 1 : SP\_2019\_NA0008\_256\_31\_20190304\_00011.jpg

LM Start	3.86	Rating **	M	Issue No.	31
LM End	3.86	Issue Type +	Ma	Location *	WS
Category	Earthen Levee			GPS Latitude/Longitude	
				Start	End
Item	Erosion / Bank Caving			38.763751 °	38.763751 °
				-121.701398 °	-121.701398 °
DWR ID	DWR_NA0008_01_s_2018_31				
Comment Code					
E1 : Note and monitor erosion site.					
Inspector Comment					
There is erosion at the toe of the levee. LMA is monitoring erosion with stakes.

View of the erosion at the toe of the levee on the waterward side. Spring 2016.

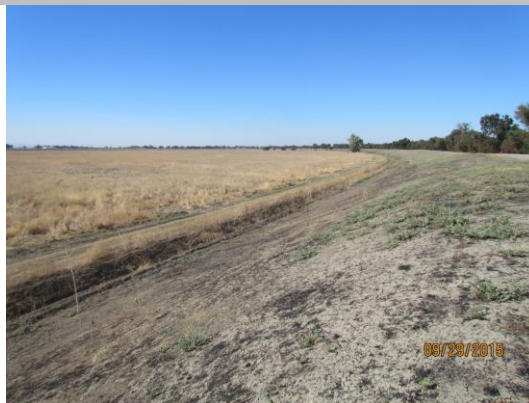
Photo 1 of 1 : SP\_2019\_NA0008\_256\_22\_20190304\_00007.jpg

View of the ditch on the landward side of the levee looking upstream.  
Fall 2015.

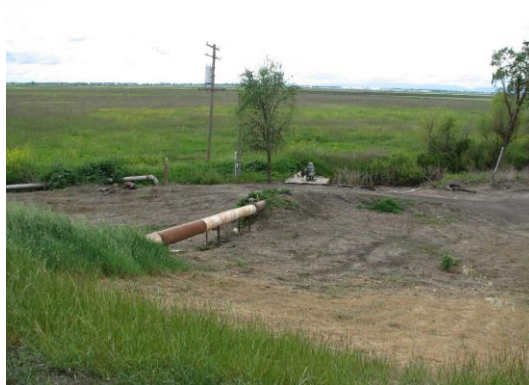
Photo 1 of 3 : UCIP\_SP\_2019\_11264\_18622.jpg

Comment Code					
Inspector Comment					
FS_ID:11264					
DS_ID:19367					
EP_NO: 4443					
Repair Type: Non-Urgent					
Crossing Status: Found					
UCIP Comments: Pipe does not have adequate cover at crown.					
FIELD_STRUCT_DESC: 16-inch steel drainage pipe through the levee,

Pump and pipe on LS toe.

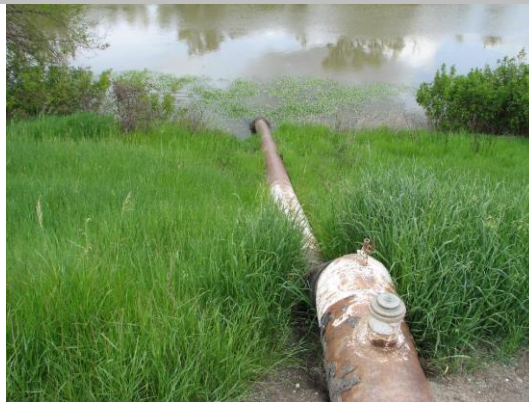
Photo 2 of 3 : UCIP\_SP\_2019\_11264\_18621.jpg

Siphon and air vent on WS shoulder.

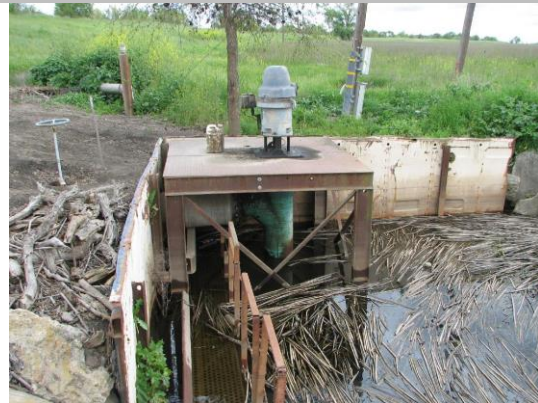
Photo 3 of 3 : UCIP\_SP\_2019\_11264\_18620.jpg

Pump on Steel pile structure with slide gate at LS toe.

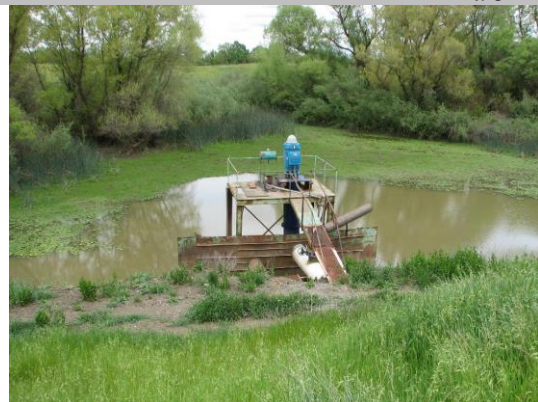
Photo 1 of 3 : UCIP\_SP\_2019\_41068\_18643.jpg

Comment Code					
Inspector Comment					
FS_ID:41068 DS_ID:19397 EP_NO: 5276 Repair Type: Non-Urgent Crossing Status: Found UCIP Comments: Pipe appears abandoned at this time. FIELD_STRUCT_DESC: 2 of 2: 20-inch steel irrigation pipe through the levee, 4.9 feet below the crown. Vertical pump unit on pile structure in stream. Siphon breaker on the landside (LS) shoulder in a 16-inch steel riser. Flap gate on the LS end. Pipe discharges into an irrigation ditch on the LS. Steel plate welded over end of pipe at pump structure. (Replaced an existing 18-inch pipe at this location under Permit No. 5276, 1966 - Reclamation District No. 730). [Additional Reference(s): DWR Levee Log, 1990]. FS Date: 4/5/2013

Pump on steel structure at WS toe.

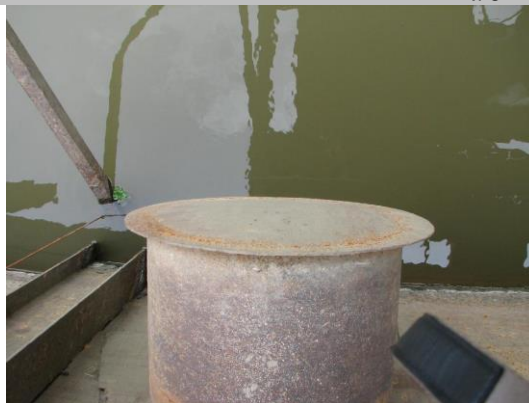
Photo 2 of 3 : UCIP\_SP\_2019\_41068\_18642.jpg

Steel plate welded over pipe end at pump platform.

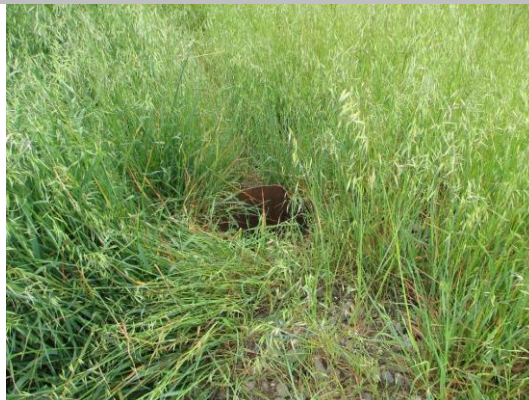
Photo 3 of 3 : UCIP\_SP\_2019\_41068\_18641.jpg

Siphon breaker buried inside 16-inch steel riser on LS shoulder.

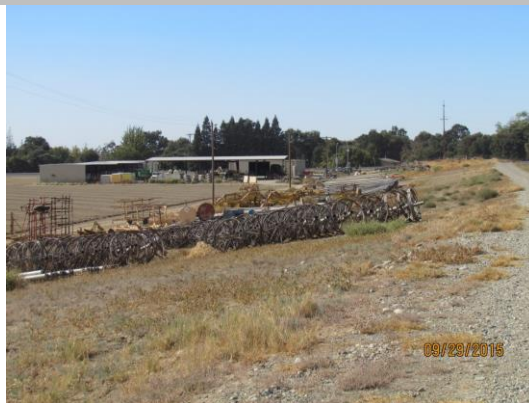
Photo 1 of 2 : SP\_2019\_NA0008\_256\_7\_20190304\_00001.jpg

View of the equipment on the landward side of the levee looking upstream. Fall 2015.

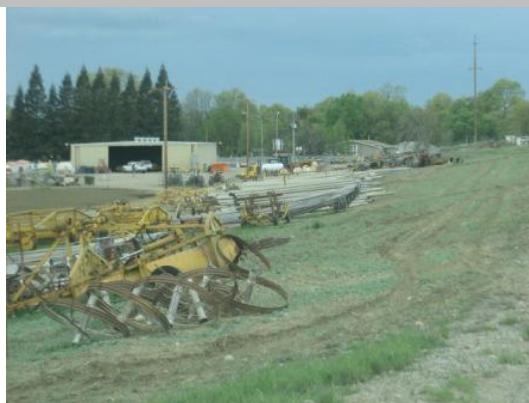
Photo 2 of 2 : SP\_2019\_NA0008\_256\_7\_20190304\_00002.jpg

A view of the equipment on the levee slope. Spring 2014

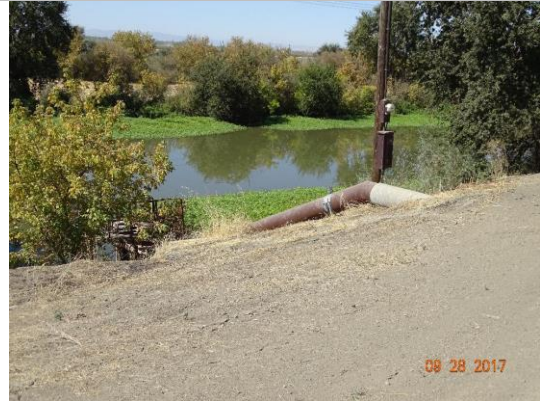
Photo 3 of 3 : UCIP\_SP\_2019\_52536\_77500.jpg

WS view: pipe and electrical panel visible.

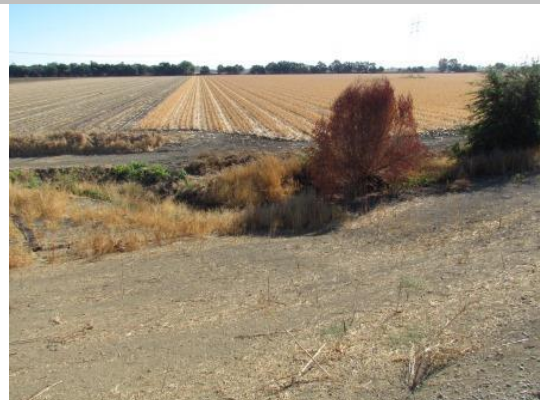
Photo 1 of 1 : SP\_2019\_NA0008\_257\_22\_20190304\_00007.jpg

View of a ditch near landside toe. Fall 2016.

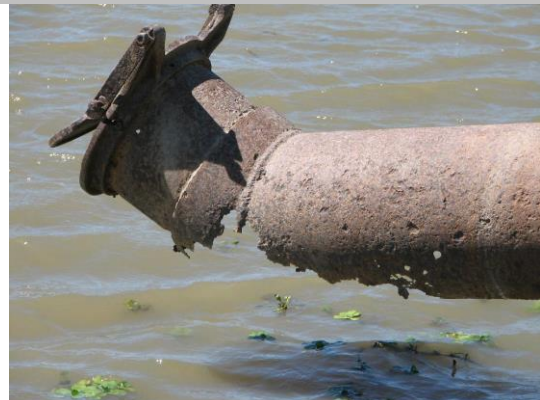
Photo 2 of 3 : UCIP\_SP\_2019\_52538\_18705.jpg

Pipe rusted through at flap gate on WS toe.

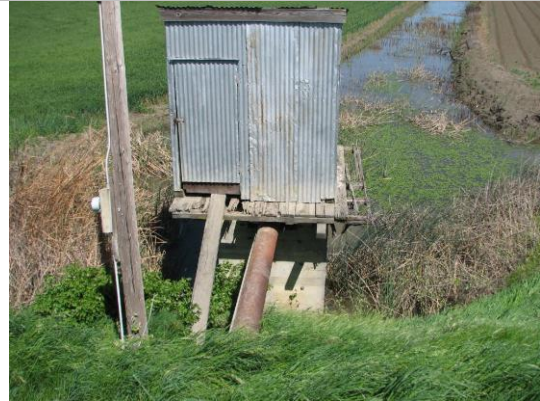
Photo 3 of 3 : UCIP\_SP\_2019\_52538\_18704.jpg

Pumphouse on concrete platform on LS toe with JP.

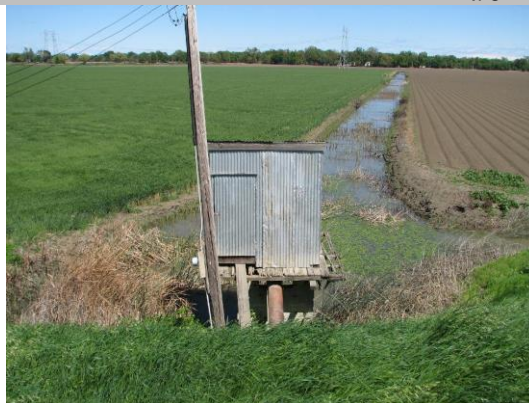
Photo 1 of 3 : UCIP\_SP\_2019\_11305\_18703.jpg

Pipe inlet located beneath pumphouse on LS toe.

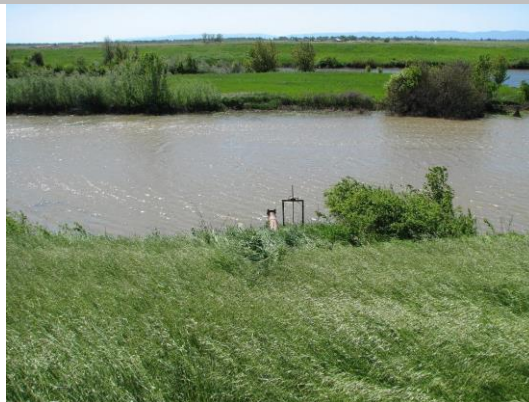
Photo 2 of 3 : UCIP\_SP\_2019\_11305\_18702.jpg

Slide gate at headwall on WS toe.

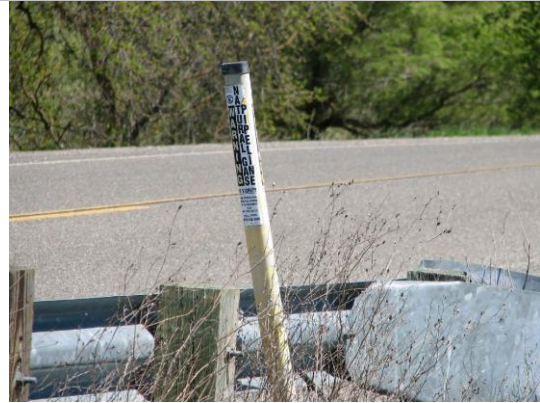
Photo 1 of 3 : UCIP\_SP\_2019\_53017\_18700.jpg

Sign on LS shoulder may indicate location of pipe, or it may indicate where pipe crosses approach ramp to bridge.

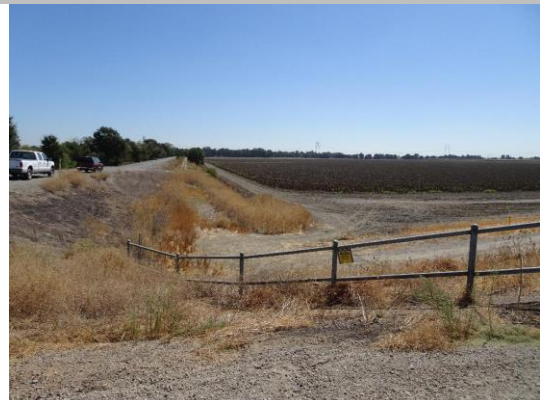
Photo 2 of 3 : UCIP\_SP\_2019\_53017\_75964.jpg

View from the levee crown looking toward the LS of the levee. gas line marker signs are visible marking an alignment parallel to the levee.

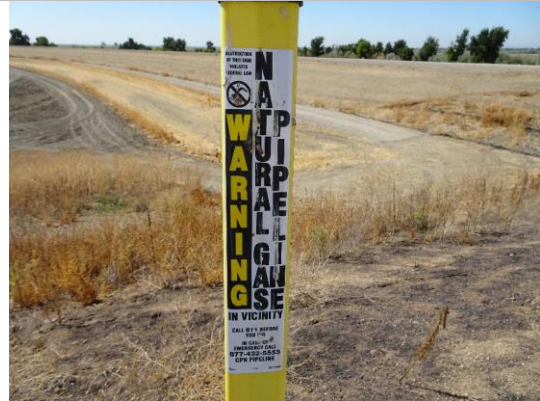
Photo 3 of 3 : UCIP\_SP\_2019\_53017\_75965.jpg

View of the marker signs information

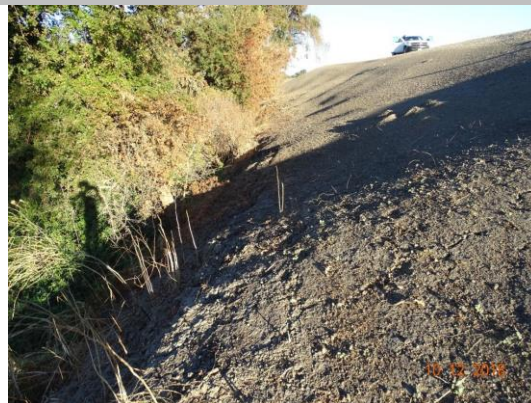
Photo 1 of 2 : SP\_2019\_NA0008\_257\_14\_20190304\_00005.jpg

View of erosion on the waterside slope. Fall 2018.

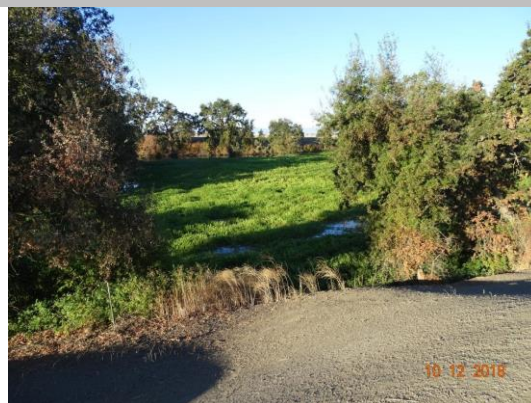
Photo 2 of 2 : SP\_2019\_NA0008\_257\_14\_20190304\_00006.jpg

View of the opening within the main channel, facing upstream. Fall 2018.

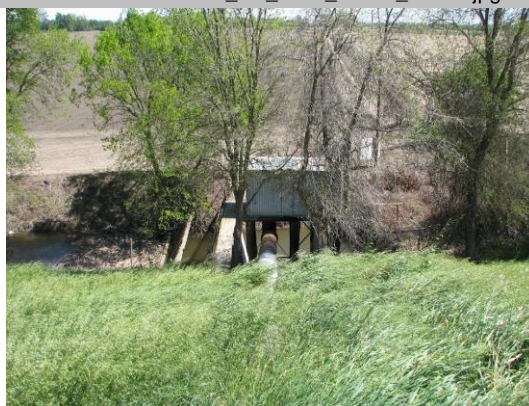
Photo 1 of 3 : UCIP\_SP\_2019\_11293\_18675.jpg

Pump on LS toe.

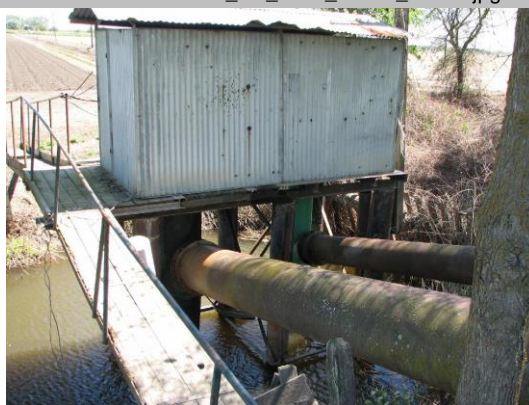
Photo 2 of 3 : UCIP\_SP\_2019\_11293\_18674.jpg

Pump and pipes on LS toe.

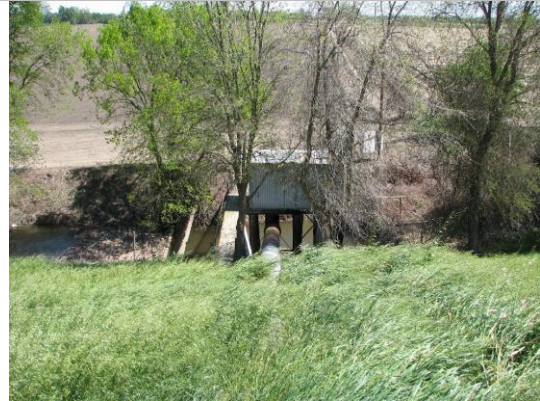
Photo 1 of 3 : UCIP\_SP\_2019\_11291\_18669.jpg

Pumphouse at LS toe.

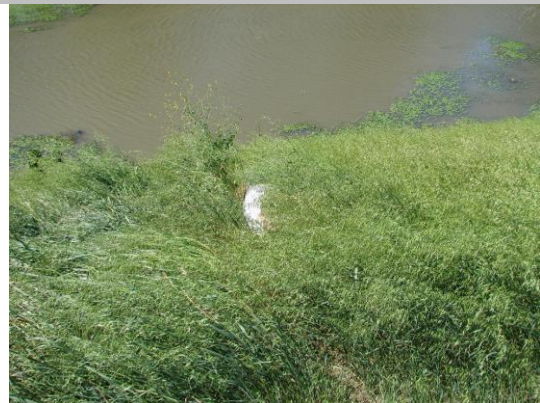
Photo 2 of 3 : UCIP\_SP\_2019\_11291\_18668.jpg

Pipe in grass on WS shoulder.

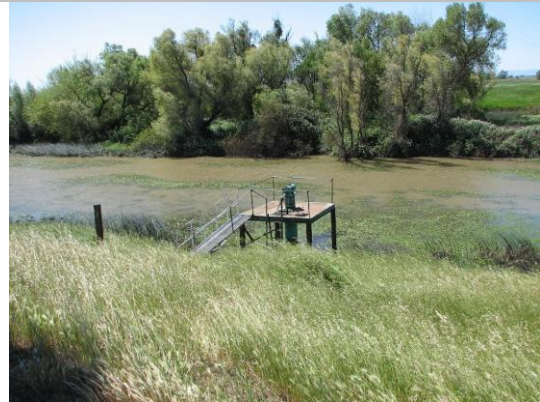
Photo 1 of 3 : UCIP\_SP\_2019\_11289\_18665.jpg

Pump on pile structure on WS toe.

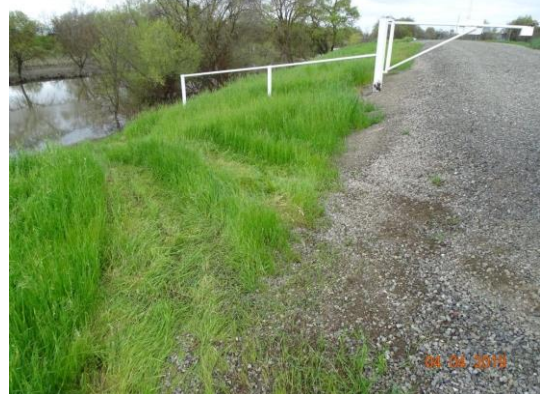
Photo 1 of 1 : SP\_2019\_NA0008\_257\_17\_20190404\_00029.jpg

View of tire tracks on the waterside slope. Spring 2019.

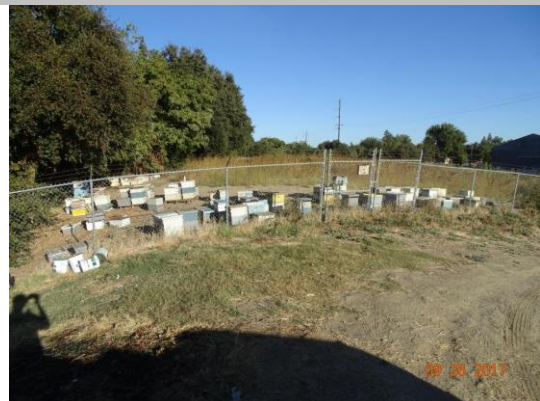
Photo 1 of 2 : SP\_2019\_NA0008\_257\_1\_20190304\_00001.jpg

View of the fence on the crown. Fall 2017.

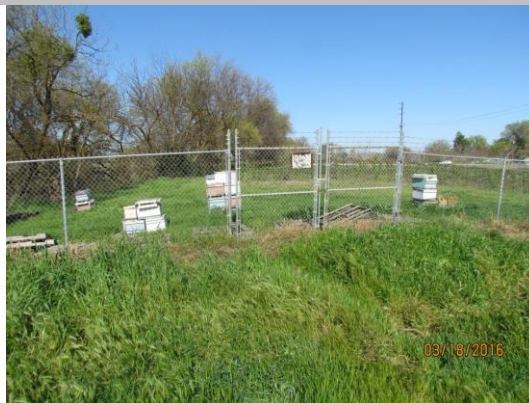
Photo 2 of 2 : SP\_2019\_NA0008\_257\_1\_20190304\_00002.jpg

View of the fence on the crown of the levee looking upstream. Spring 2016.
